Smoke and Dye Testing Summary

High Level Sewershed

Run Summary —							
Test ID	Test Type	Date Inspected	Company / Super.	Blower MH	Ground Condition	Notification Made?	Total Length
S1028-217	Smoke	8/10/2009	ADS/TM	S19KK_031MH	Dry	Yes	560.78

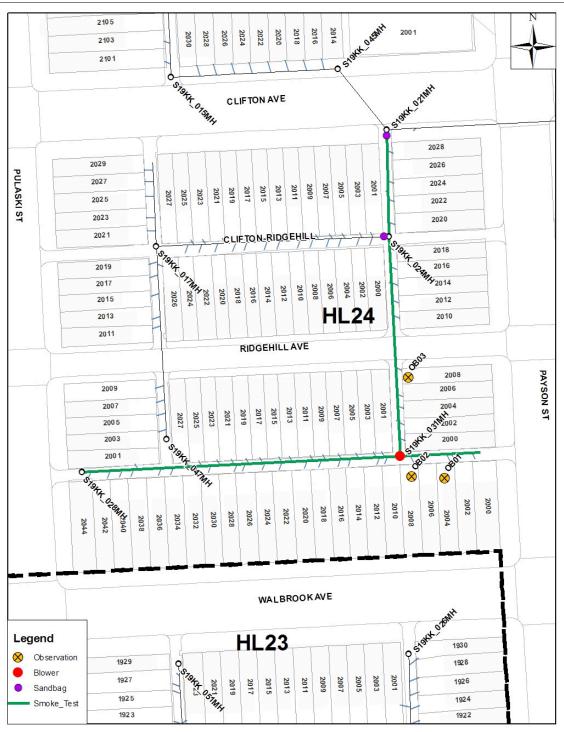
Obs_ID S1028-217-OB01 **Address** 2004 Walbrook Ave

Nearest MH S19KK_031MH
Comments Smoke from cleanout in back yard. 2004

Walbrook Ave.
